## **APISSEQ Sisimiut – Greenland**

### **1st winter survey 2011**

**Report nr. SR 11-01  
DTU BYG  
March 2011**

This report summarizes the very first survey of the engineering dormitory Apisseq in Sisimiut, Greenland. The dormitory was inaugurated in August 2010 and the survey was performed in March 2011. The experienced problems and their possible causes are explained in the report. Furthermore possible solutions are suggested.

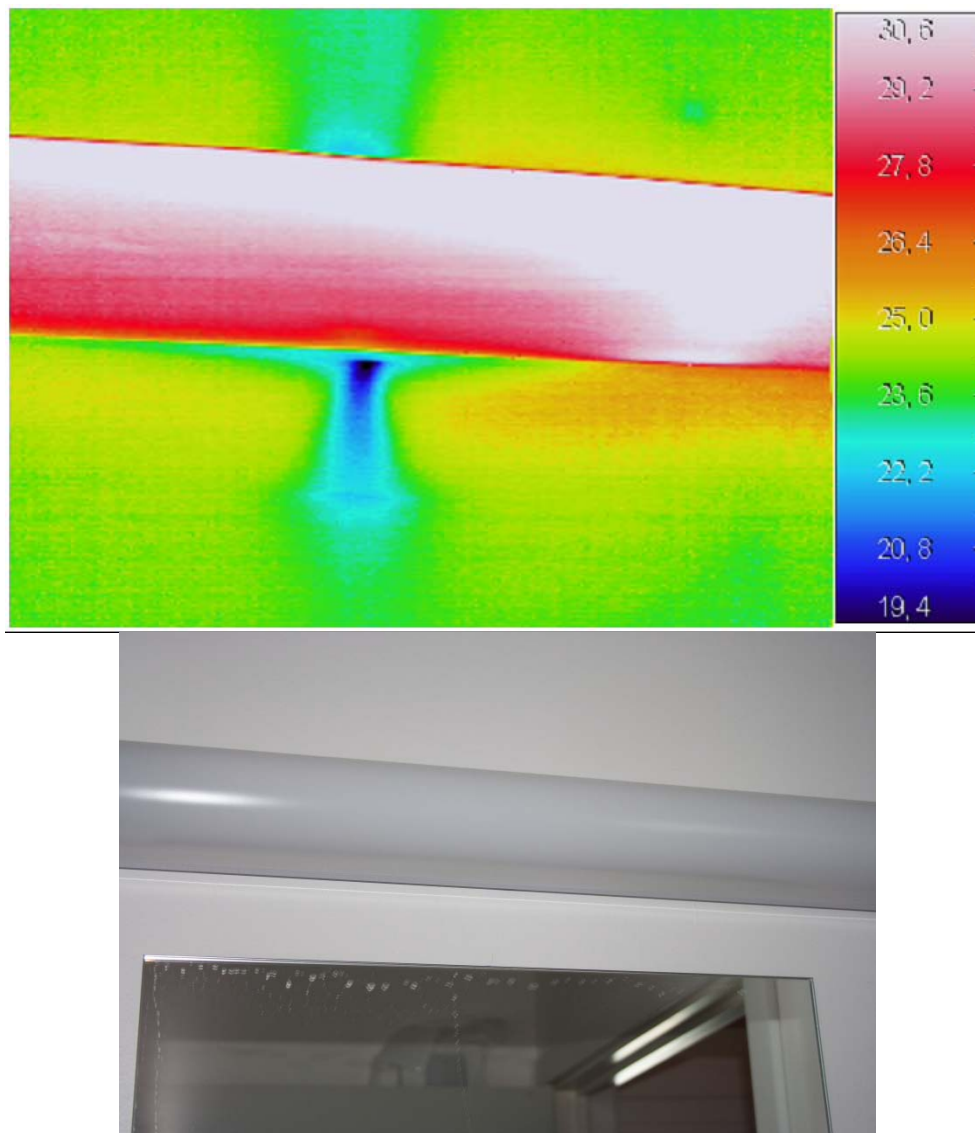
Figure 5 - Air leakage from behind the light in the bath room

In the Figure 5 the leakage from behind the wall-mounted light, shows most likely the penetration of the vapour barrier by the electricity cable, or mounting screw.

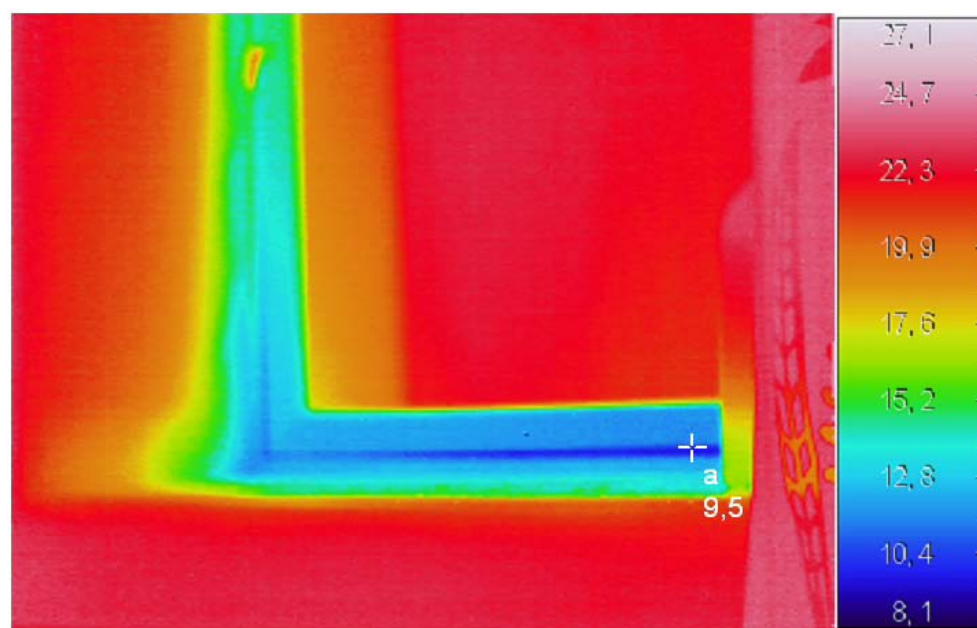
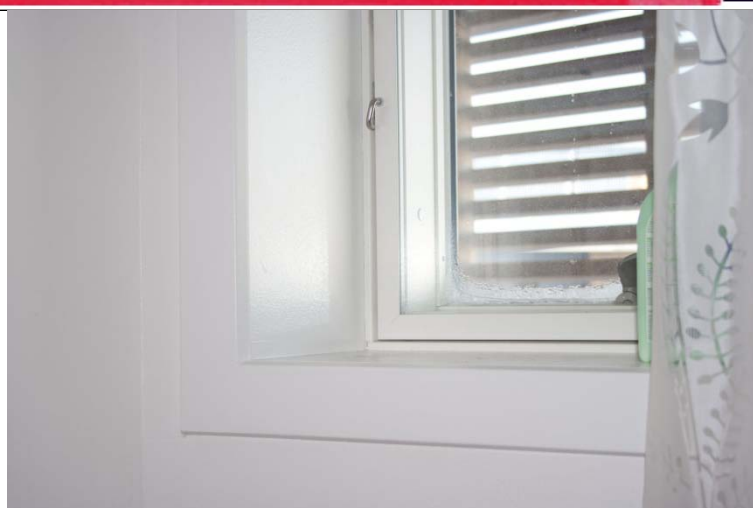
**Figure 6 - Leakage around the bath room window**

Figure 6 displays the insufficient sealing of the crack between the third removable glass pane and the window frame. This untightness also causes penetration of the moisture from bathroom to the window gap and its condensation and freezing on the middle glass pane (see Figure 7).

The third removable glass panes should be sealed and attached to the frames properly so the exfiltration of the air from the space to the window gap will be avoided.

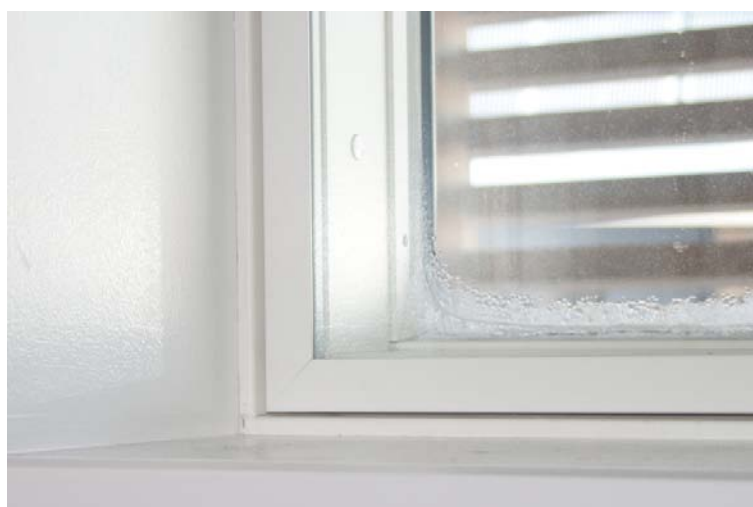
**Figure 7 - Condensation and frost formation on the window pane in the bath room**

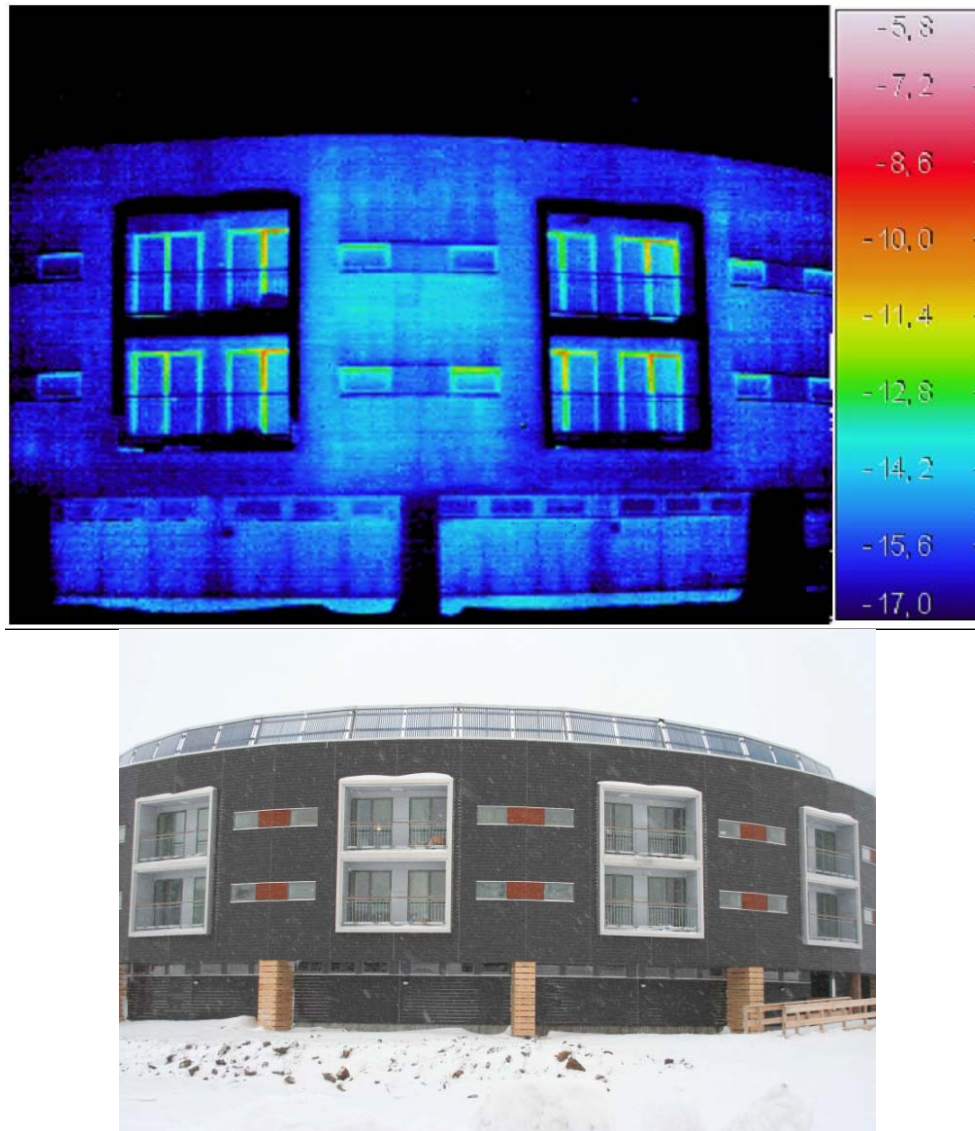
The pictures of the facade show, that the significant thermal bridges are created mainly by the window frames of the large windows/balcony doors. They are larger in case of balcony doors compare to the fixed windows (see Figure 8 and Figure 9).

Figure 8 – South-western facade

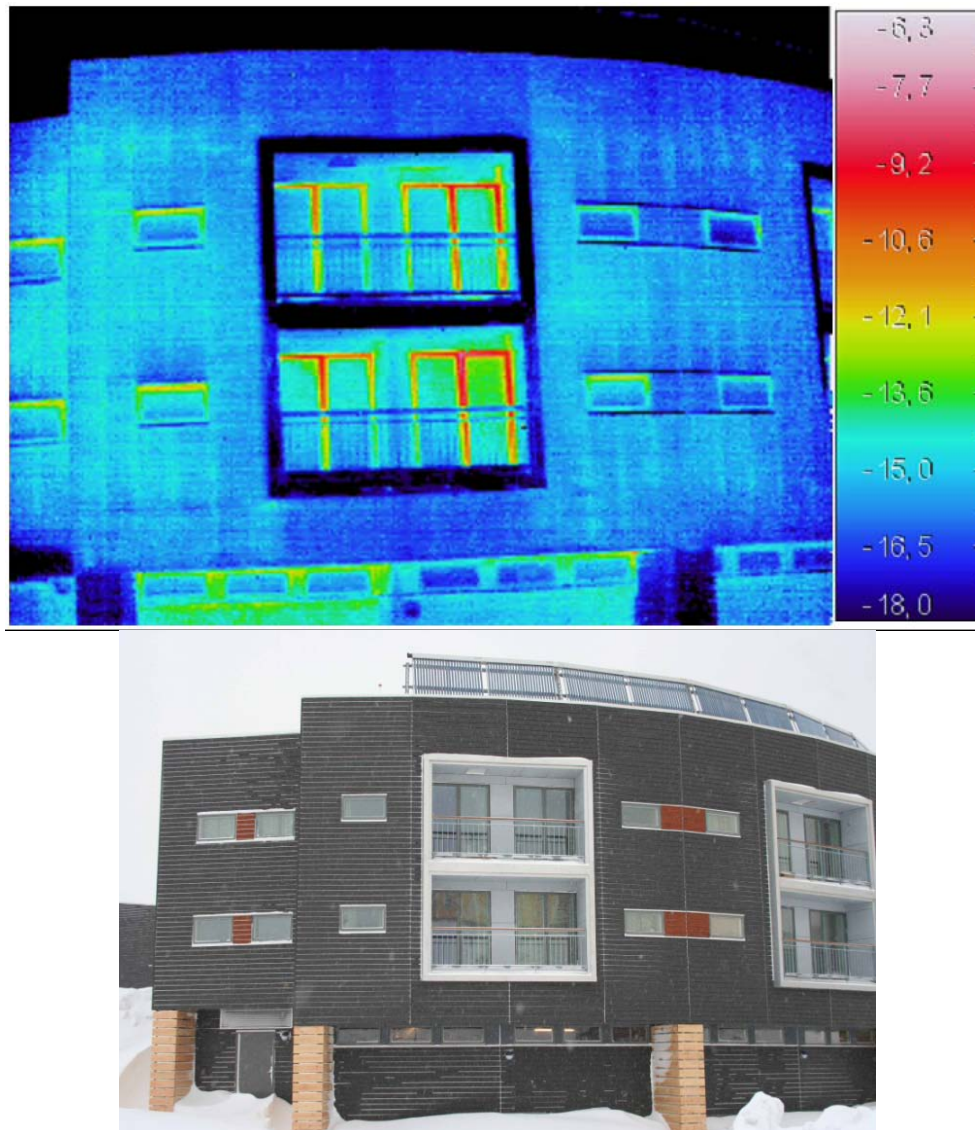
**Figure 9 – Western facade**

In Figure 9 it is possible to see the warmer facade (meaning higher heat loss) from the technical room (down left) with the ventilation unit. It is caused by the lack of insulation of this room and insufficiently insulated ventilation ducts in that room. The heat loss from the ducts heats up the room. Higher room temperature then increases the heat loss through the uninsulated facade. As a result of this phenomenon the fresh supply air which was heated in the ventilation unit is being cooled before it is delivered to the space.

The technical rooms with ventilation units should be additionally insulated to avoid extra heat losses.

The ducts in the technical (unheated) rooms should be insulated with at least 100 mm of thermal insulation to avoid heat losses and the air supplied to the rooms should have a temperature of 20 °C

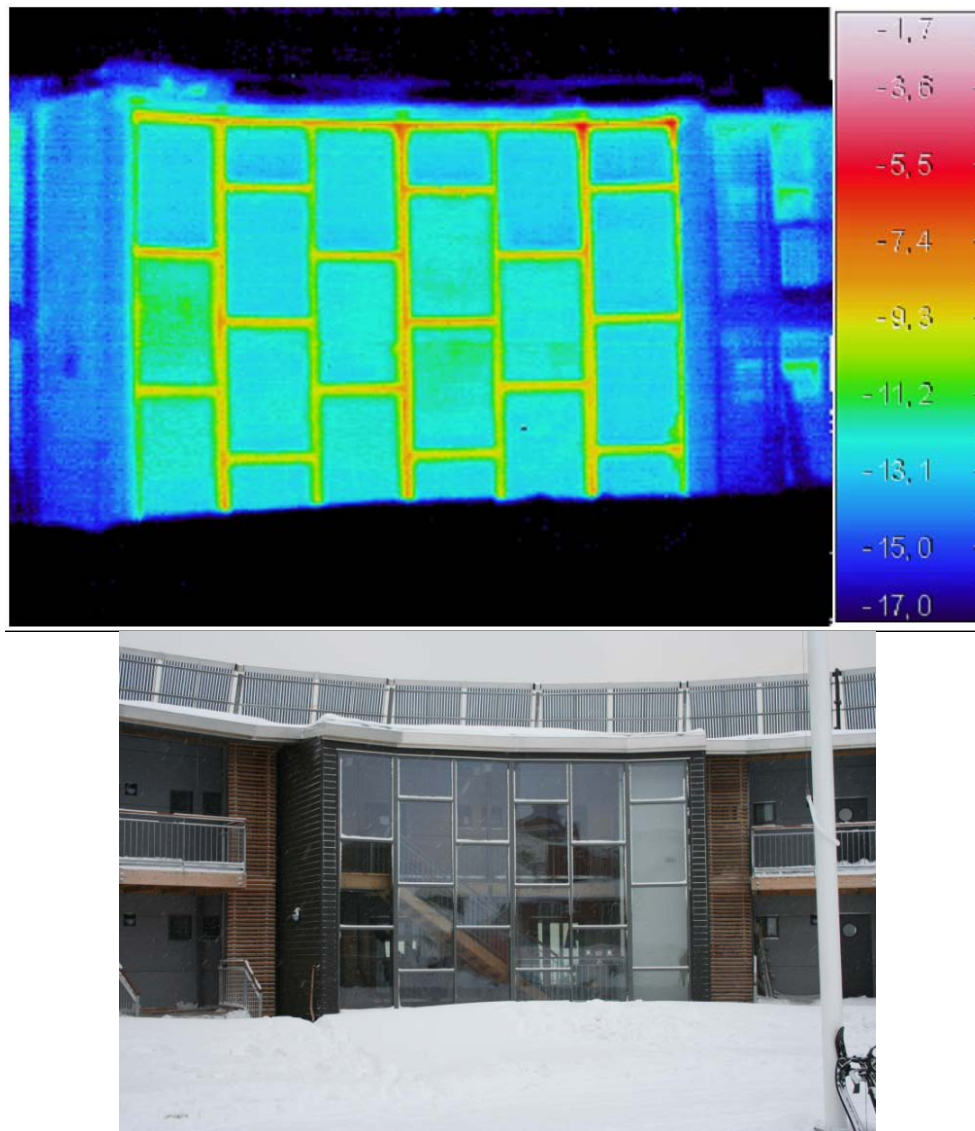
In section 3.1 the heat loss from the glazed part of the atrium was estimated. From Figure 10 it is obvious that the actual heat loss will be even higher due to thermal bridges of the window frames.

Figure 10 - Glazed atrium facing north

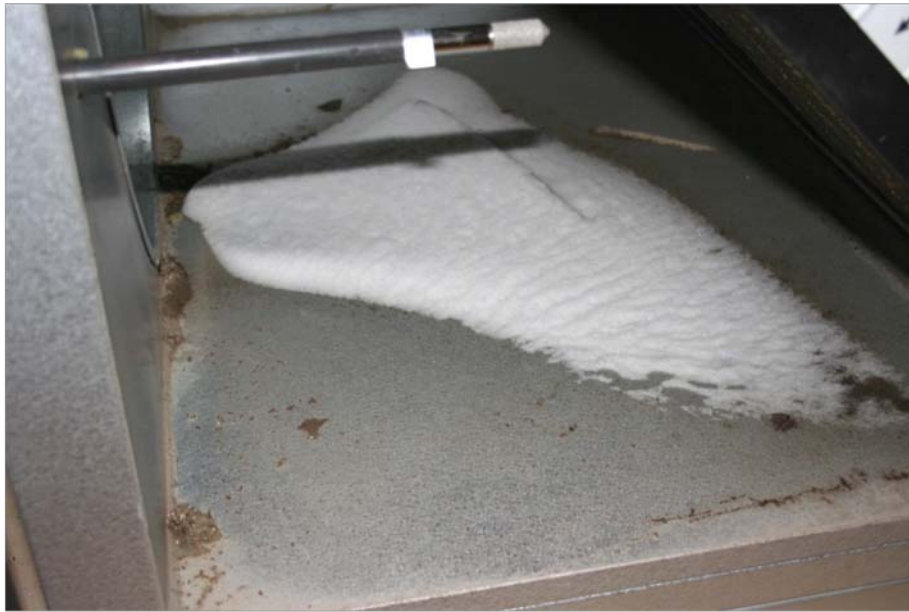
In the Figure 11 and Figure 12 the identical chamber could be seen before it started snowing and after 24 hours of light snowing outside. Significant amount of snow was sucked with the supply air into the unit during that period.

Figure 11 - Ventilation unit - snow accumulation in the supply air chamber – before it started snowing

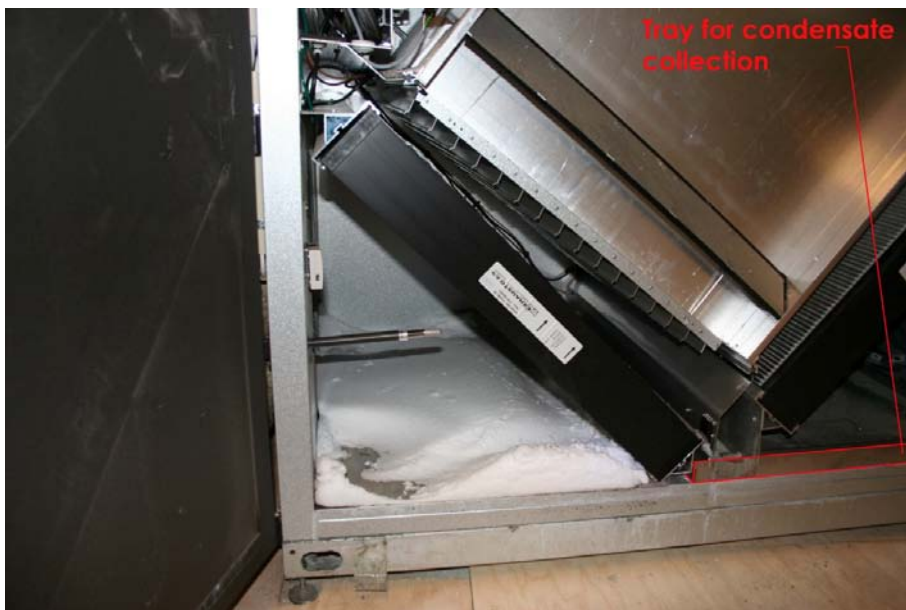
Figure 12 - Ventilation unit - snow accumulation in the supply air chamber – after 1 day of light snowing (10 cm of snow/day)

There is a risk that in case of long lasting snowing the chamber will be filled with snow which may affect the air flows or in the worst case put the unit out of order until the snow melts. The other risk is the water accumulation inside the chamber after the snow melts. The unit has a metal tray for collecting the liquid condensate and draining it out of the unit, but it is only placed under the exhaust chamber (see Figure 12). After the snow in the tight supply chamber melts, the water will create a small lake where the bacteria could start to grow.

The intake on the facade should be better protected from the snow and the drainage of the melted snow from the unit should be enabled.

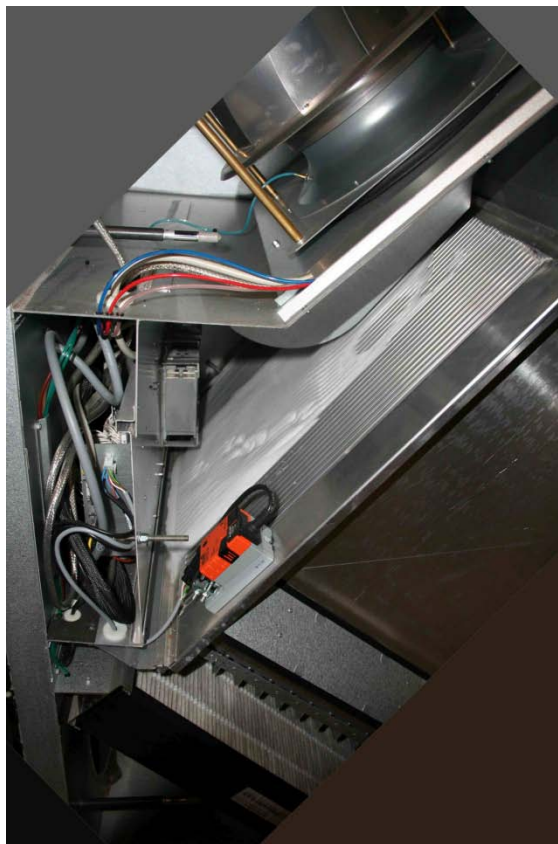
The units are equipped with the by-pass of the cold supply air in cases that freezing appears. The by-pass damper however doesn't take any action even in cases where the frost formation is obvious (see Figure 13). It is probably caused by the wrong setup of the unit.

**Figure 13 - Cross flow heat exchanger with frost formation**

The defrosting strategy of the heat exchangers should be checked and adjusted so the by-pass damper opens when it is supposed to. It should be controlled by the pressure loss of the heat exchanger possibly in combination with the outdoor temperature. In case that the temperature of the incoming air is below freezing point and the pressure loss increases without increase of the air flow, the frost is most likely blocking parts of the heat exchanger. It means, that the defrosting function should be activated.
